## 7.1 Institutional Values and Social Responsibilities

### 7.1.6 Quality audits on environment and energy are regularly undertaken by the institution

**Viswajyothi College of Engineering and Technology  
Vazhakulam, Muvattupuzha**

**POLICY DOCUMENT ON ENVIRONMENT & GREEN ENERGY USAGE**

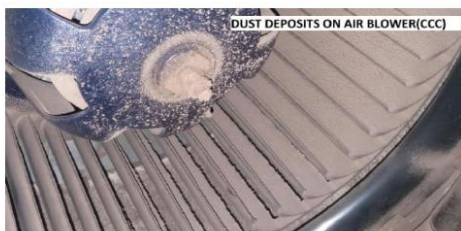
3. No thermal cutoff is seen even at higher temperatures in most of the air conditioned rooms.
4. The indoor air filters as well as air blowers and the outdoor units are clogged with heavy dust

DUST DEPOSITS ON AIR BLOWER(CCC)

1. Carry out overhauling including cleaning
2. Reset to higher temperature levels, so that cutoff can be achieved
3. Restrict the operating hours to office hours in academic blocks
4. Install water coolers in weather proof condition and follow standard wiring practices
5. Rectify defects and leakages
6. Repair the unit near DBMS lab.

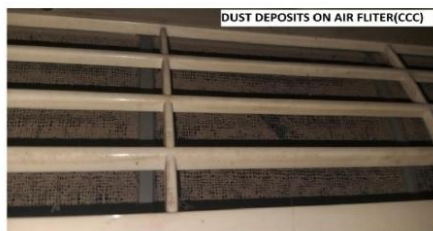
DUST DEPOSITS ON AIR FILTER(CCC)

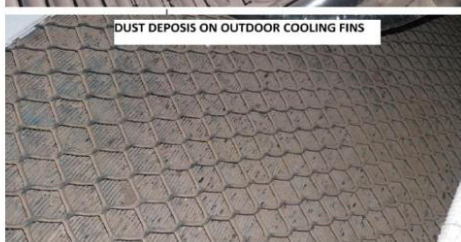
DUST DEPOSITS ON OUTDOOR COOLING FINS

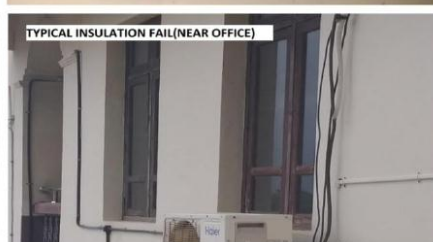
TYPICAL INSULATION FAIL(NEAR OFFICE)

9. The refrigerant pipes of A/Cs are to be properly insulated wherever damages noticed.
10. Replace the outdoor unit of A/C(General make) near office to the open area for better air circulation

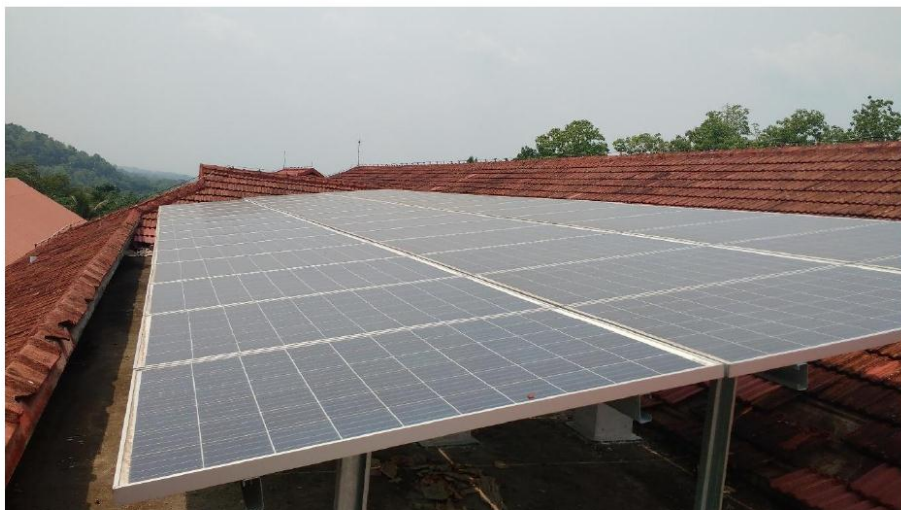
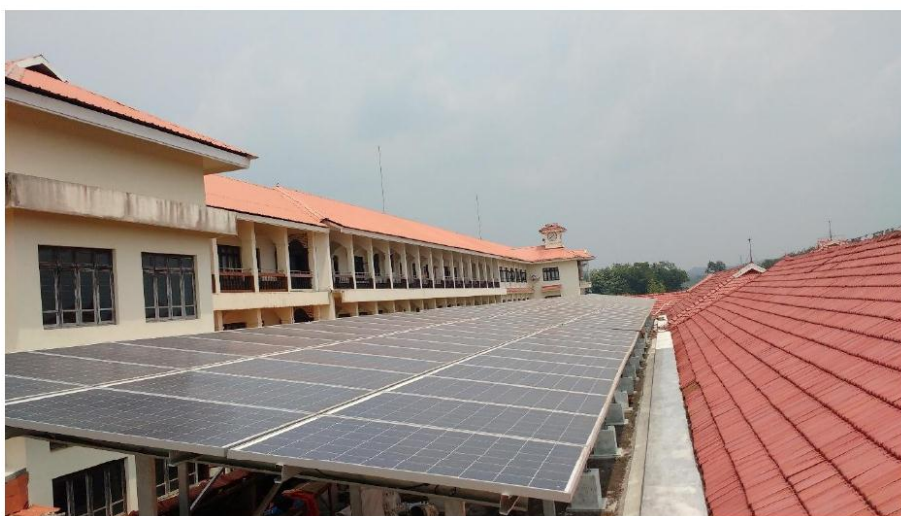
Photographs of 50 kW solar power plant installed on roof top
